THE EFFECTS OF FRICTION IN THE CONTROL SYSTEM ON THE  
HANDLING QUALITIES OF A C-54D AIRPLANE

Donald B. Talmage and John P. Reeder

Langley Aeronautical Laboratory  
Langley Field, Va.

WASHINGTON  
November 8, 1948

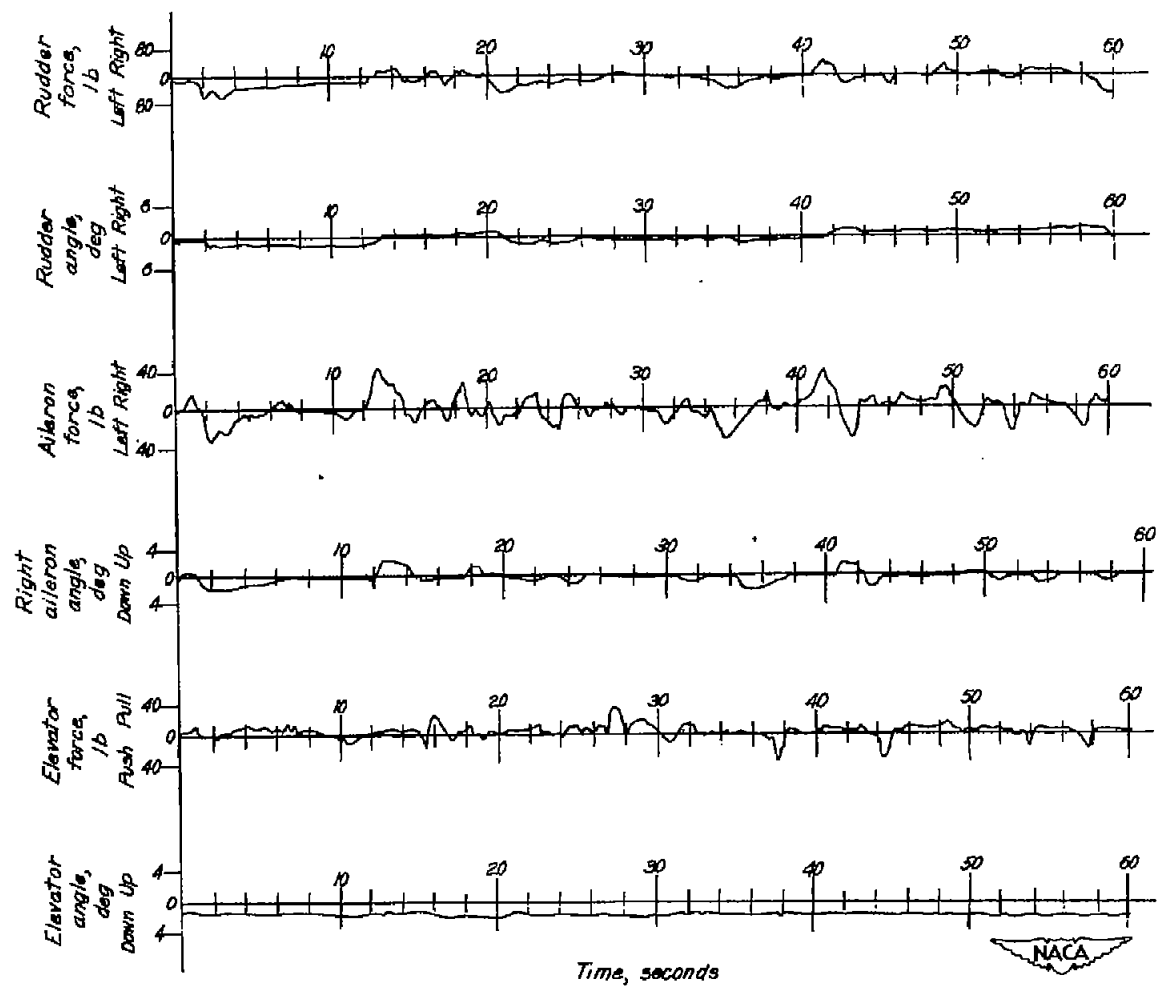
(a) Automatic-pilot servo-units installed.

Figure 1.- Time history of a beam-bracketing operation. C-54 airplane, clean condition, 200 miles per hour.

Several flight conditions were investigated both with the servo-units in and with the servo-units out. Figure 1 presents time histories of the control forces and control movements during typical beam-bracketing operations, with the two different magnitudes of friction. Figure 2 presents time histories of typical normal power-off landings with the two different magnitudes of friction.

The preceding considerations indicate that the act of piloting with high friction in the control system becomes a continual process of quick force applications while moving the control very little. An example is presented in figure 1 which shows comparable time histories of beam-bracketing operations with high and low friction. The continual process of quick force applications with high friction is immediately apparent in figure 1(a).

The elevator force varies continually with little motion of the elevator; the aileron force, especially around 28 seconds and 46 seconds, varies without motion of the ailerons, and the rudder force, especially around 16 and 46 seconds, varies with little movement of the rudder. In figure 1(b) the continual quick force applications are nearly absent. The physical effort put forth by the pilot is therefore considerably increased when friction is present.

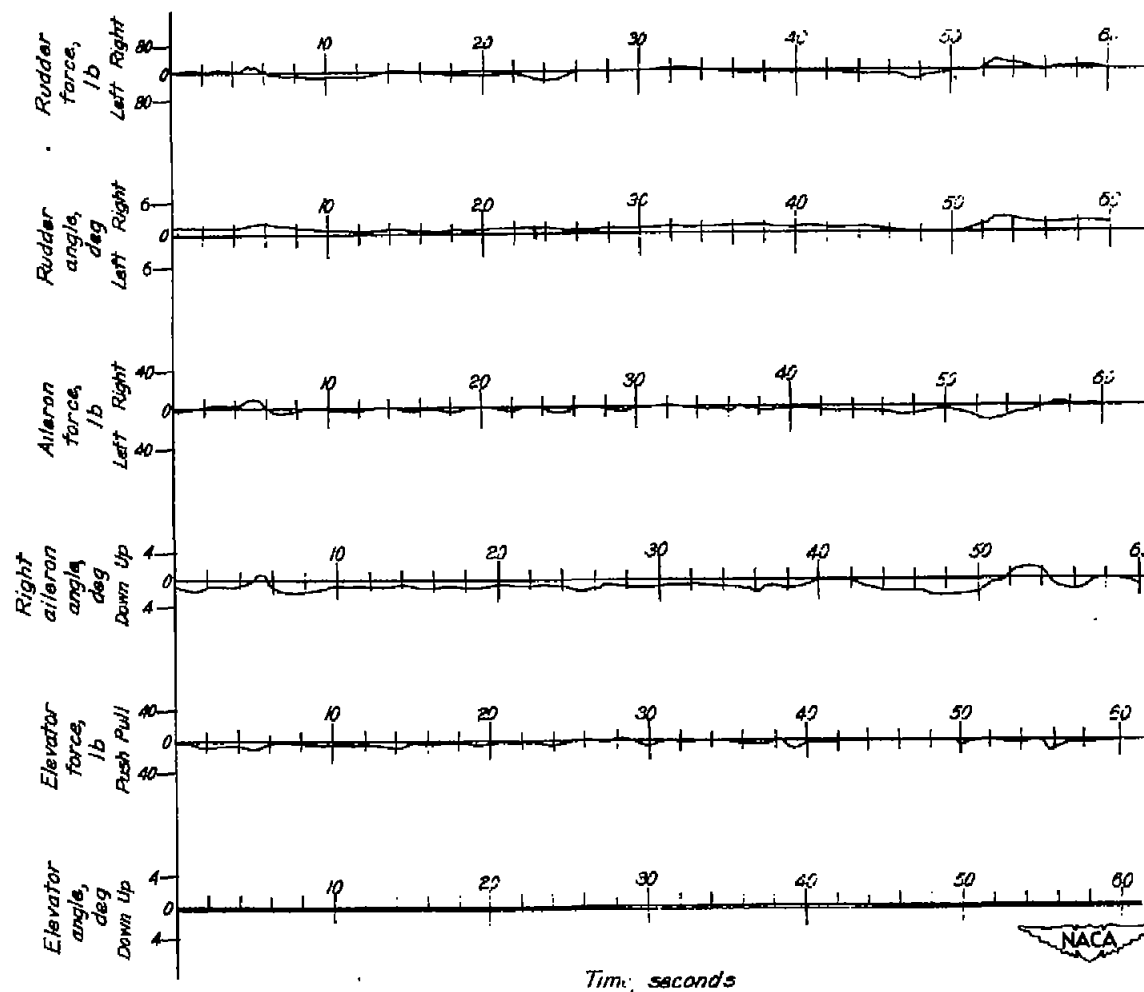
Figure 1.- Concluded.

(b) Automatic-pilot servo-units removed.

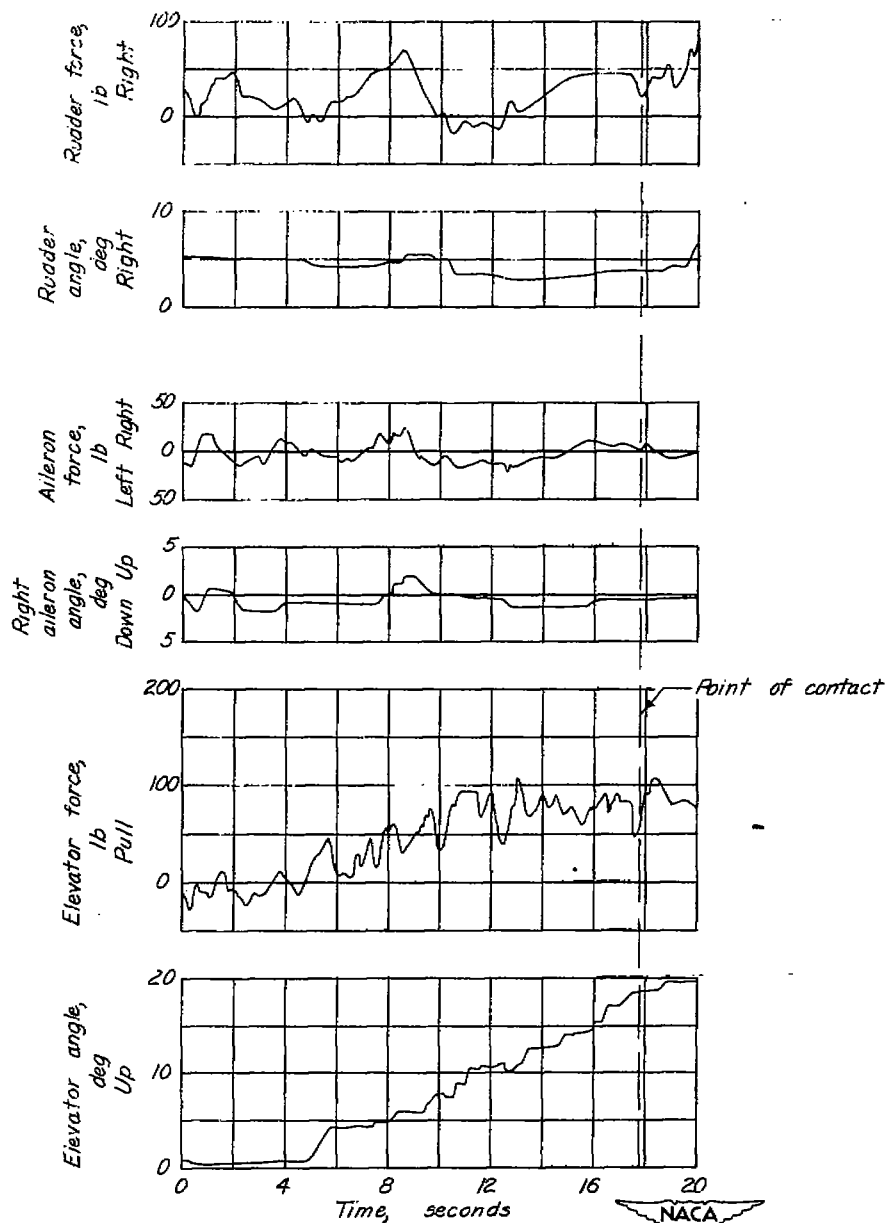
(a) Servo-units installed.

Figure 2.- Time history of a landing. C-54 airplane, flaps full down, gear down, power off.

Aside from the standpoint of less physical work for the pilot, there is the more important consideration of making the control deflection follow closely the control force. Figure 2, which presents time histories of power-off landings with high and low control friction, shows how excessive friction can destroy the response of the control surface to applications of force at the control column. An equal amount of physical effort was involved in both landings, but the increased friction in figure 2(a) over that in figure 2(b) was sufficient to eliminate any correlation between the respective control forces and deflections.

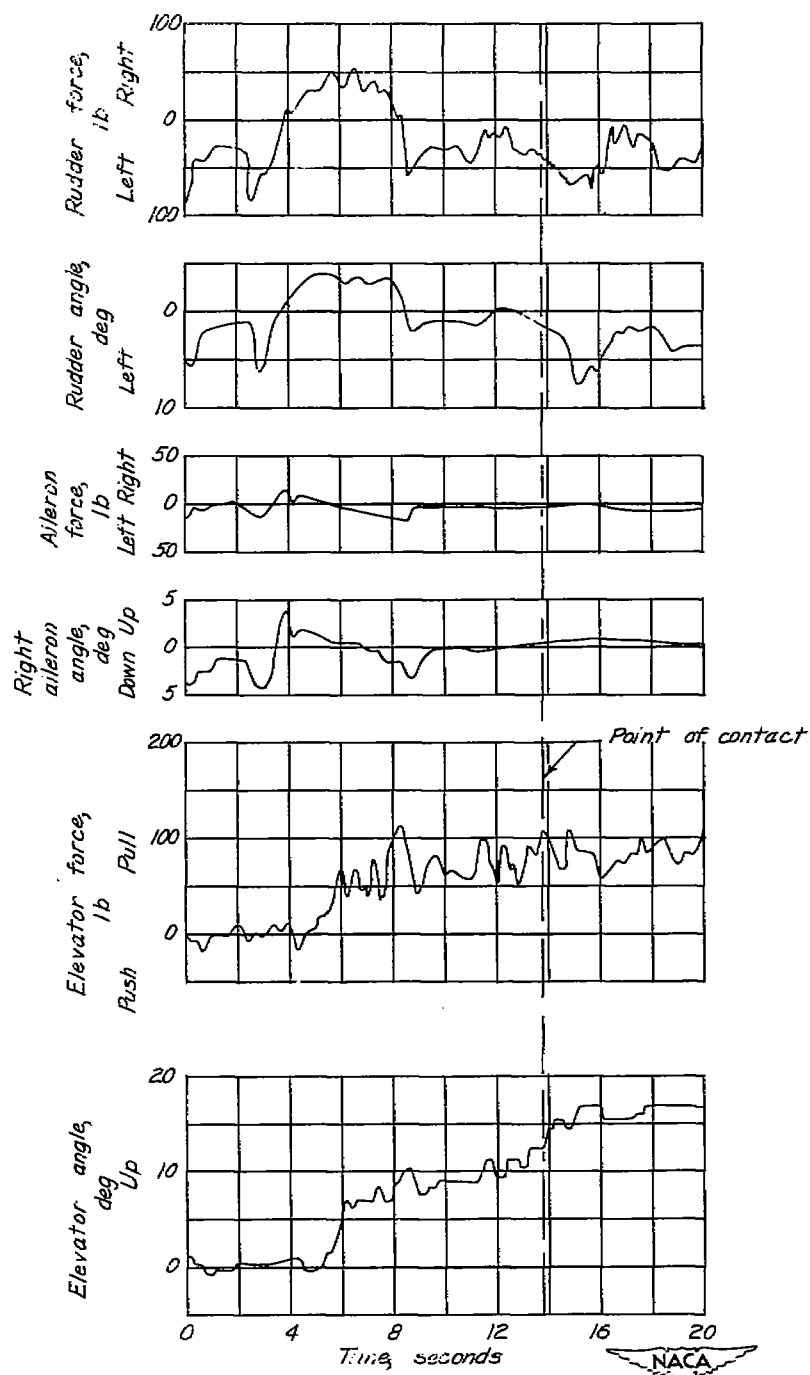
Figure 2.- Concluded.

(b) Servo-units removed.
